NASA/TM-2007- 215084
NESC-RP-07-13/06-050-E

Independent Review Support for Phoenix Mars Mission Robotic Arm Brush Motor Failure

NASA Engineering and Safety Center Technical Report	Document #: RP-07-13	Version: 1.0
Title: Independent Review Support for Phoenix Mars Mission Robotic Arm Brush Motor Failure			Page #: 1 of 54

March 8, 2007

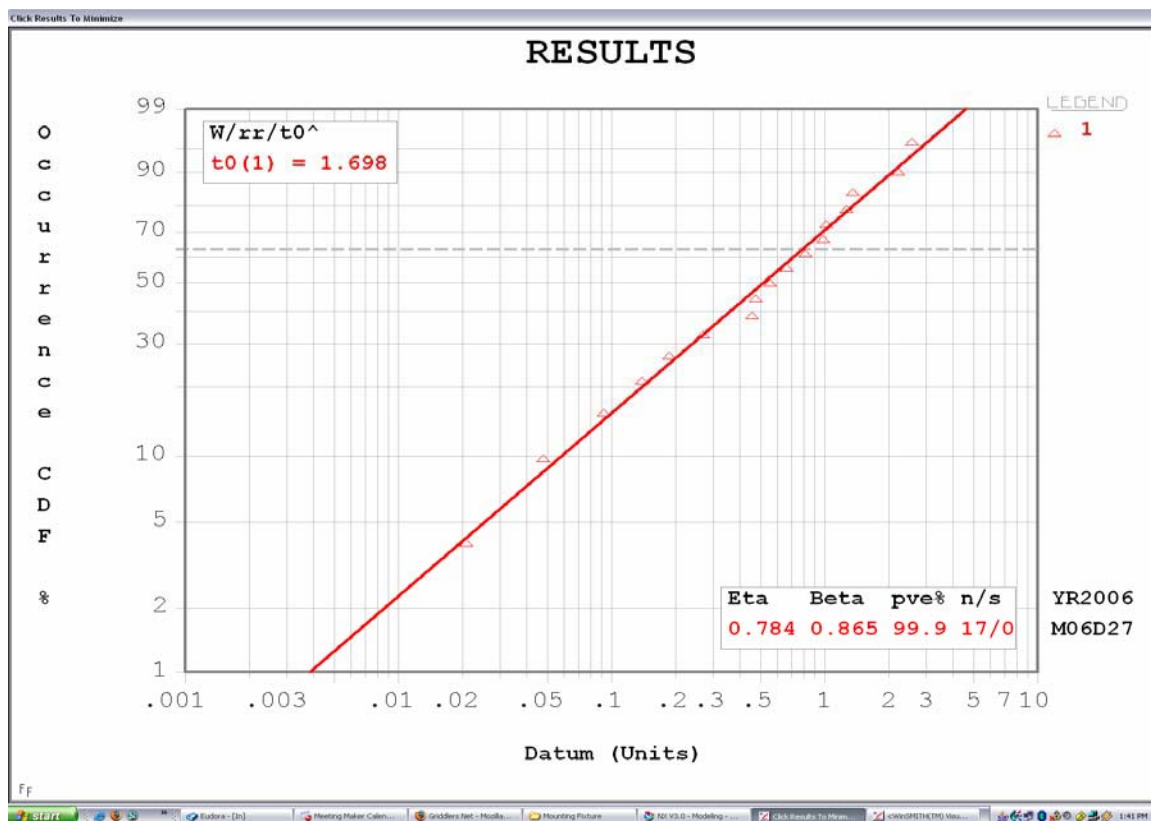
Figure 2. Three Parameter Weibull without Outlier

The data was reevaluated after omitting the indicated outlier. The data fit is shown in Figure 2, which in this case, had a pve% of 99.9.

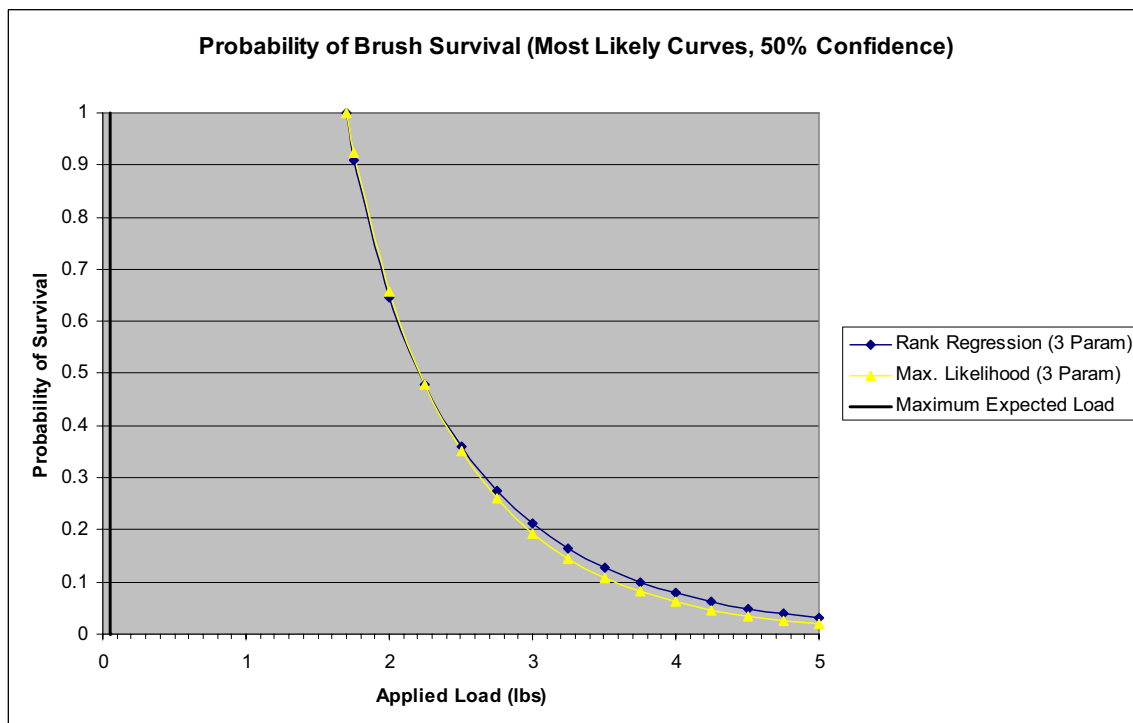
Figure 3. Probability of Survival

Inputting values for F_0 , η , and β , generated by the analysis software using both Rank Regression and Likelihood Ratio methods of into the above equation yielded the following results shown in Figure 3.

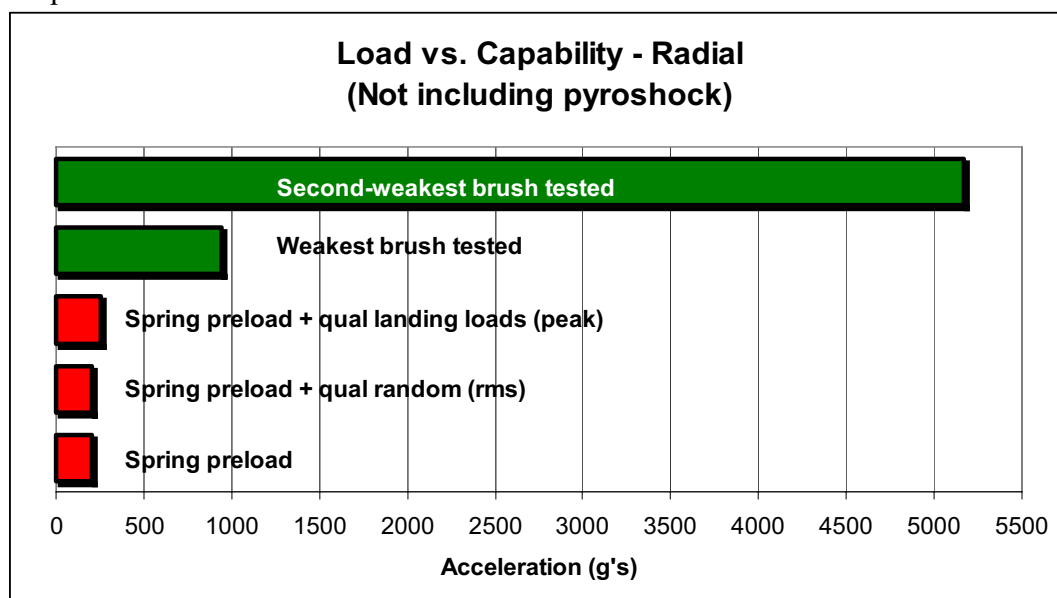
Radial	g's	lb force
Spring Preload	200	0.041
Spring preload + Qual random	207.8	0.043
Spring preload + qual landing loads	258	0.053
Weakest brush found	945	0.196
Second weakest brush	5166	1.070
